December 19, 2022
Project 2103691

**Re: 2022 Landfill Inspection Report for the
Weston Disposal Site No. 3
Wisconsin Public Service Corporation
Town of Knowlton, Marathon County, Wisconsin**

WDS3 ASH LANDFILL CCR COMPLIANCE - ANNUAL INSPECTION**INSPECTOR:** William Butler, PE**INSPECTION DATE/TIME:** 11/22/2022**WEATHER:**

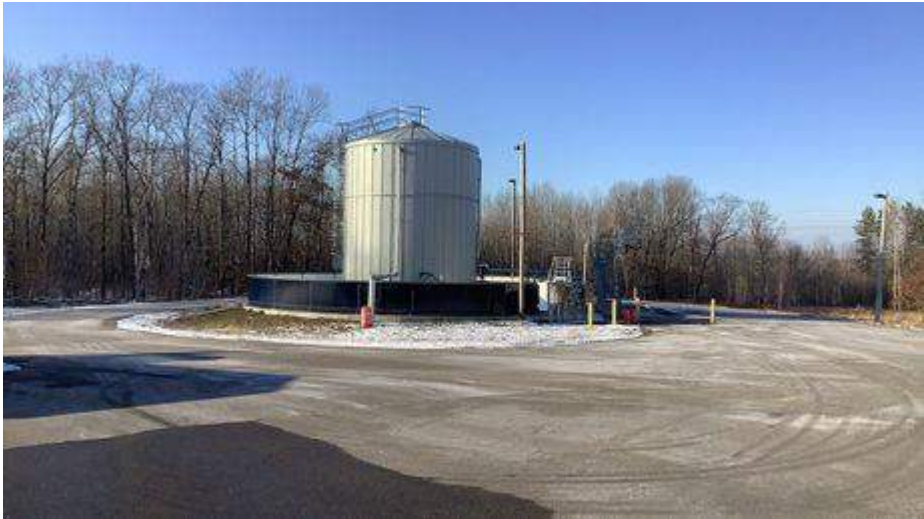
PHOTOGRAPH NO: 1	DATE: November 22, 2022	LATITUDE: 44.7270139551537	LONGITUDE: -89.6428701756124
SITE LOCATION: WESTON, WISCONSIN			
DESCRIPTION: Leachate collection tank and loadout facility.

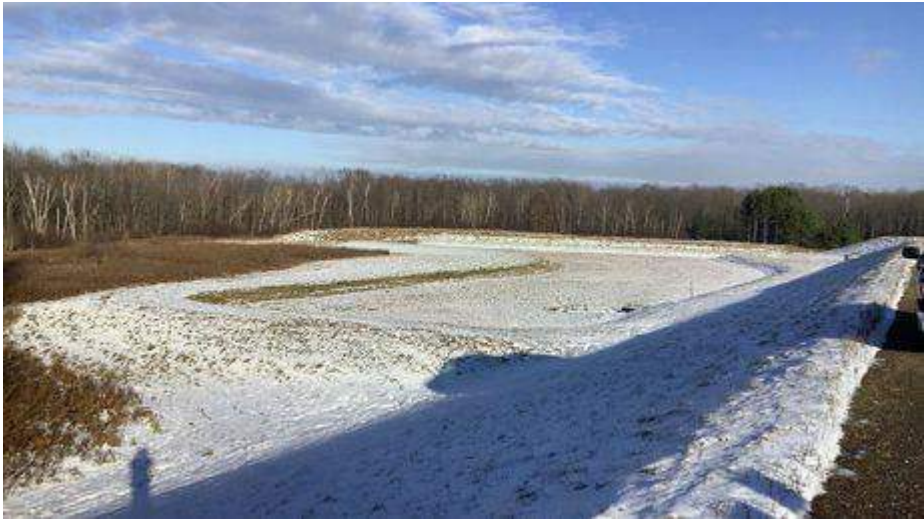
PHOTO BY: BILL BUTLER			
PHOTOGRAPH NO: 2	DATE: November 22, 2022	LATITUDE: 44.7260192449485	LONGITUDE: -89.6371589722821
SITE LOCATION: WESTON, WISCONSIN			
DESCRIPTION: Storm water basin no.1 pond, taken on the north landfill berm, looking east.

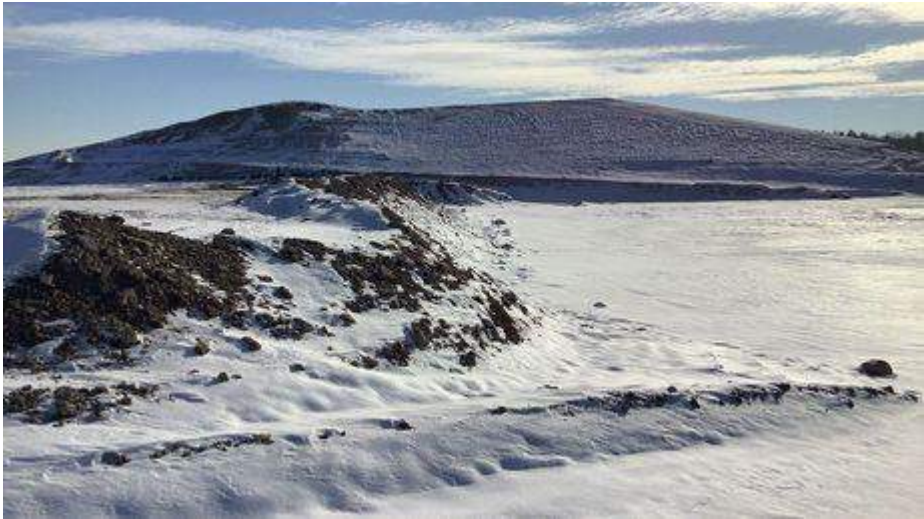
<p>PHOTO BY:</p> <p>BILL BUTLER</p>			
PHOTOGRAPH NO: 3	DATE: November 22, 2022	LATITUDE: 44.7253545694234	LONGITUDE: -89.6357830654781
SITE LOCATION: WESTON, WISCONSIN			
<p>DESCRIPTION:</p> <p>In the foreground, shown is the extent of placement of the 4-foot frost protection layer in cell 1. In the background, is the north slope of cell 2. The photo was taken looking south.</p>

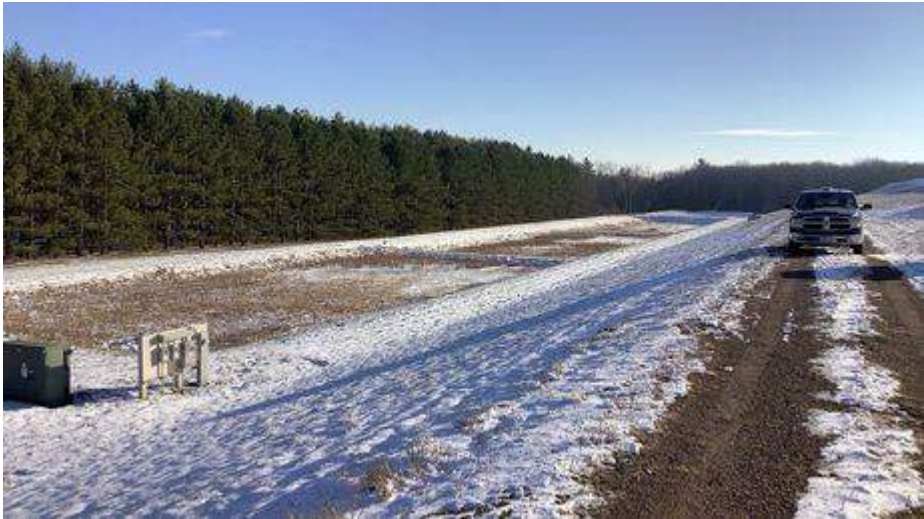
PHOTOGRAPH NO: 6	DATE: November 22, 2022	LATITUDE: 44.7248623525963	LONGITUDE: -89.6349188504667
SITE LOCATION: WESTON, WISCONSIN			
DESCRIPTION: Stormwater basin no. 2 Photo taken from the east landfill berm looking south.

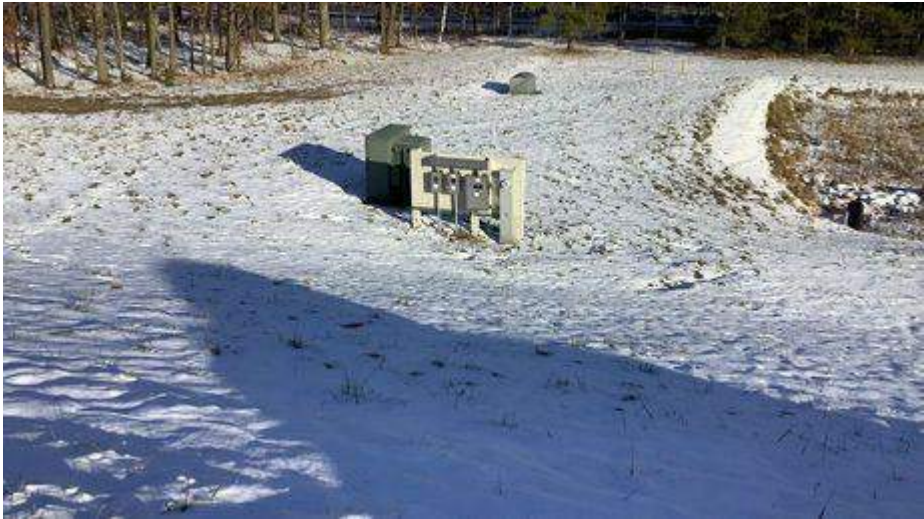
PHOTO BY: BILL BUTLER			
PHOTOGRAPH NO:	DATE: November 22, 2022	LATITUDE: 44.7248439323228	LONGITUDE: -89.6349470482454
Delete photo from log SITE LOCATION: WESTON, WISCONSIN			
DESCRIPTION: Cell 2 leachate collection control panel east side of cell 2

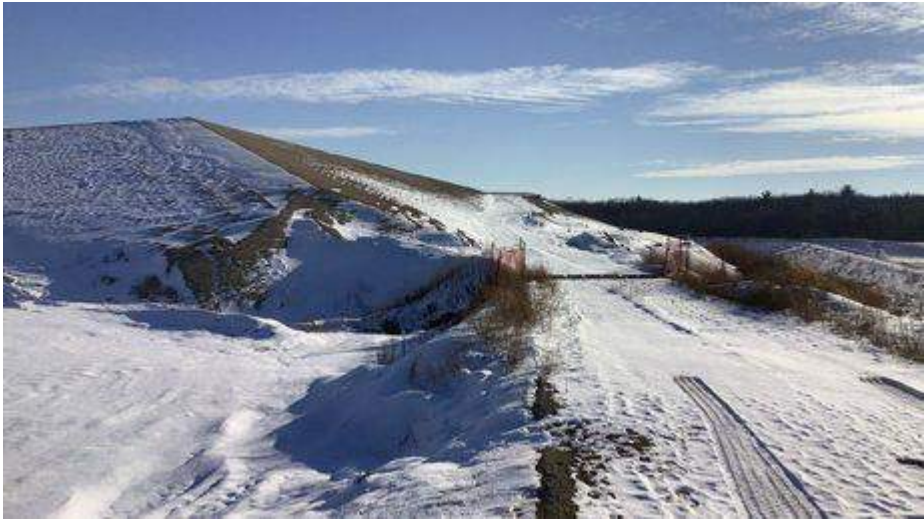
PHOTOGRAPH NO:	DATE:	LATITUDE:	LONGITUDE:
Delete photo from log	SITE LOCATION: WESTON, WISCONSIN		
DESCRIPTION: Looking south at the west slope cell 2

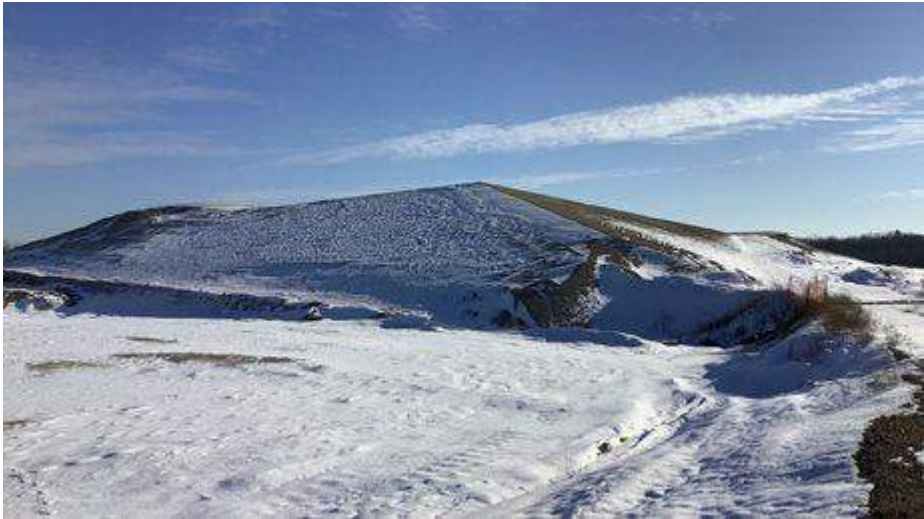
Comments : The Cell 2 final cover slopes appear stable with no observed instability, no significant erosion, no woody vegetation, no animal burrows, or concerns regarding the final cover slopes. Everything appeared to be in good condition with no observed instability or significant erosion.

PHOTO BY: BILL BUTLER			
PHOTOGRAPH NO: 7	DATE:	LATITUDE:	LONGITUDE:
SITE LOCATION: WESTON, WISCONSIN			
DESCRIPTION: Shown is the north slope of cell 2. The cover was placed in 2022.

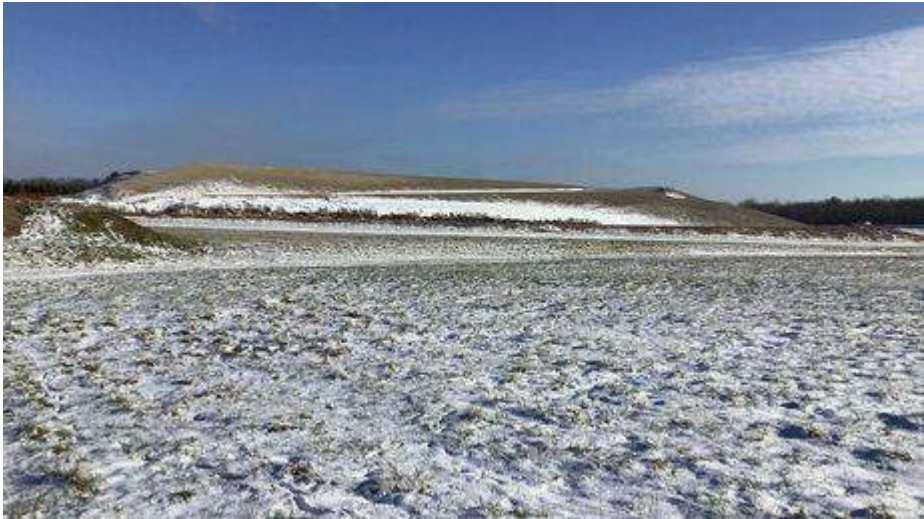
PHOTOGRAPH NO: 8	DATE: November 22, 2022	LATITUDE: 44.7249580390356	LONGITUDE: -89.6386231576116
SITE LOCATION: WESTON, WISCONSIN			
DESCRIPTION: Looking east at the west slope for cell 2.

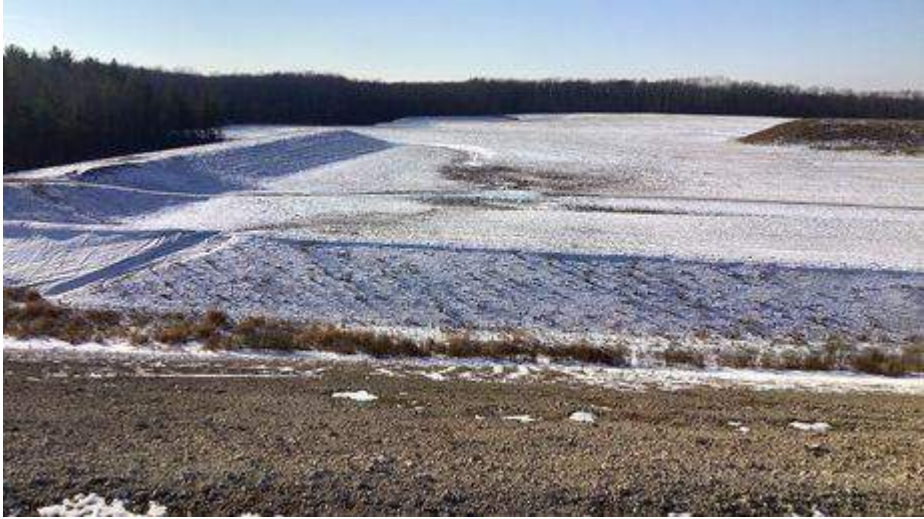
PHOTO BY: BILL BUTLER			
PHOTOGRAPH NO:	DATE: November 22, 2022	LATITUDE: 44.7232181095683	LONGITUDE: -89.6358991341884
Delete photo from log SITE LOCATION: WESTON, WISCONSIN			
DESCRIPTION: Future expansion area, taken from cell 2 crest looking west

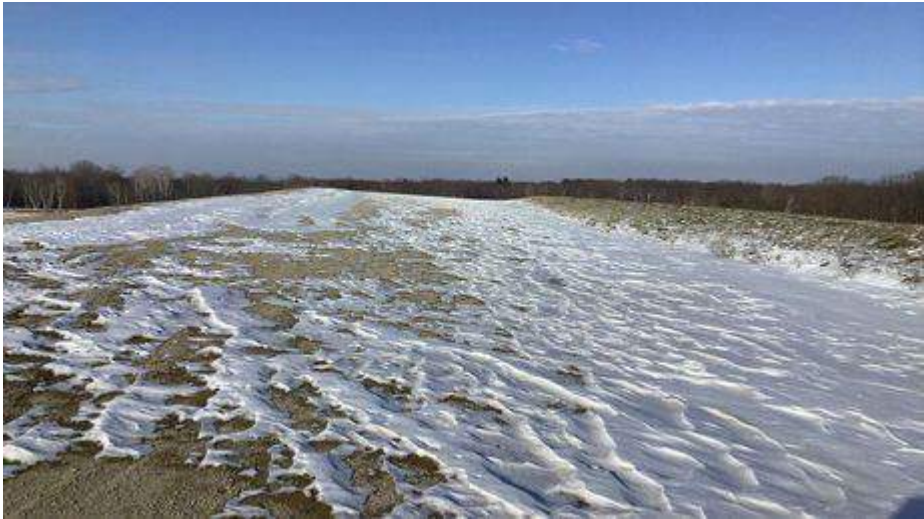
PHOTOGRAPH NO: 9	DATE: November 22, 2022	LATITUDE: 44.7232676463016	LONGITUDE: -89.6357964522053
SITE LOCATION: WESTON, WISCONSIN			
DESCRIPTION: Taken from the south edge of cell 2, looking north at the final cover crest.

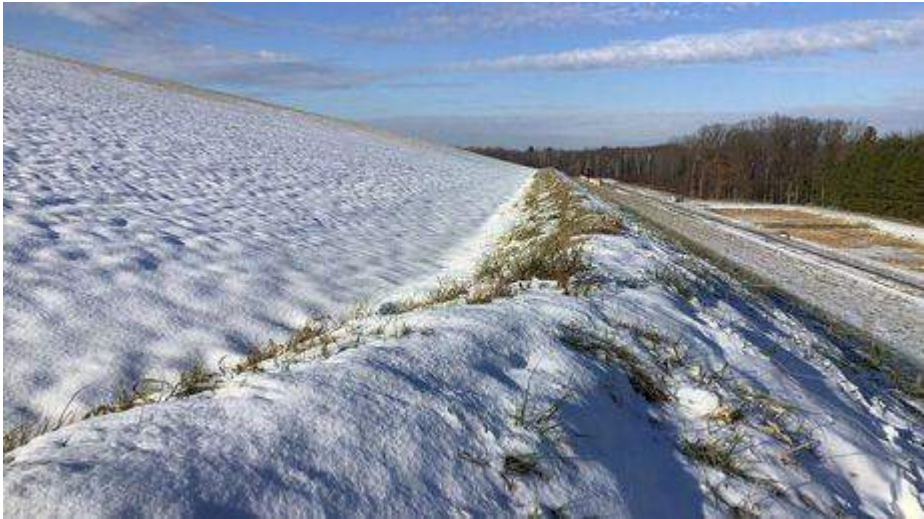
PHOTO BY: BILL BUTLER			
PHOTOGRAPH NO: 10	DATE: November 22, 2022	LATITUDE: 44.7228513038638	LONGITUDE: -89.6349624394725
SITE LOCATION: WESTON, WISCONSIN			
DESCRIPTION: Looking at the east slope and storm water control ditch for cell 2. Photo taken at the southeast corner of cell 2.

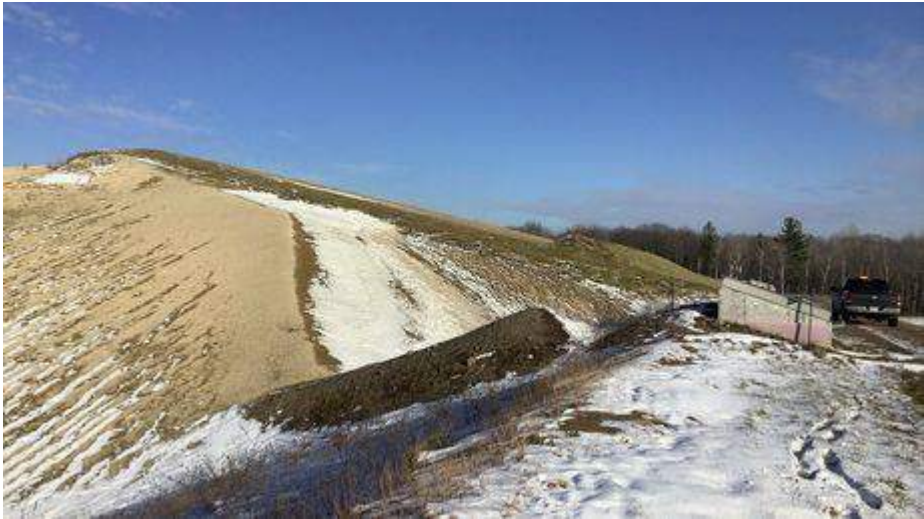
PHOTOGRAPH NO:	DATE:	LATITUDE:	LONGITUDE:
Delete photo from log	SITE LOCATION: WESTON, WISCONSIN		
<p>DESCRIPTION:</p> <p>Cell 2 perimeter leachate collection vault and clean out southwest corner</p>	 		
<p>PHOTO BY:</p> <p>BILL BUTLER</p>			
PHOTOGRAPH NO: 11	DATE:	LATITUDE:	LONGITUDE:
	SITE LOCATION: WESTON, WISCONSIN		
<p>DESCRIPTION:</p> <p>Looking east at the cell 2 south slope. Photo taken at the southwest corner of cell 2.</p>
