December 19, 2025

Project No. 2103691

**Re: 2025 Landfill Inspection Report
Weston Disposal Site No. 3
Wisconsin Public Service Corporation
Town of Knowlton, Marathon County, Wisconsin**

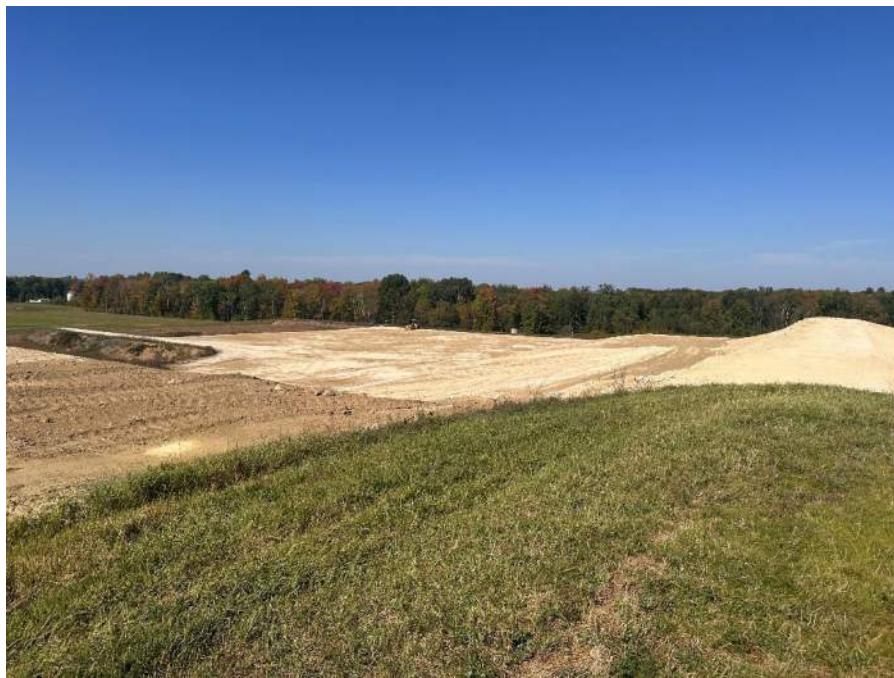
Photo No. 1 – Active filling area on Cell 1 and Cell 2, looking north.

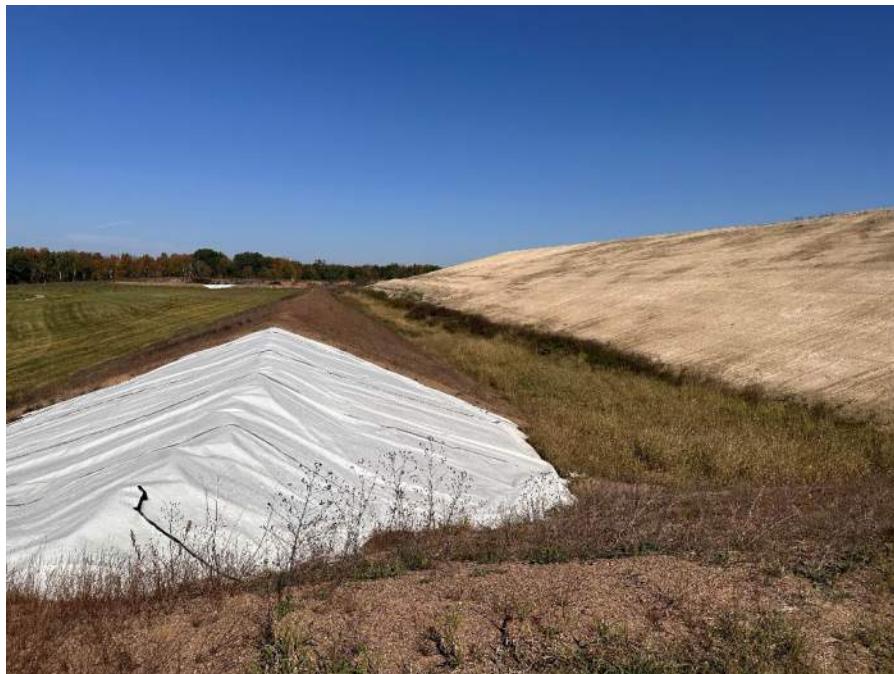
Photo No. 2 – Cell 2/3 intercell berm and leachate collection ditch along west side of Cell 2.

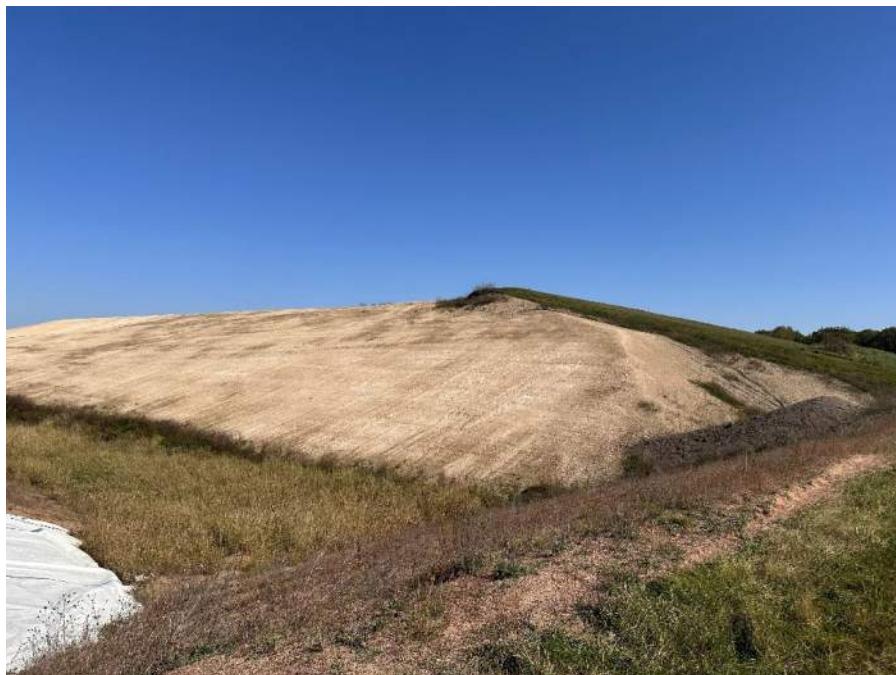
Photo No. 3 – Cell 2 west slope.

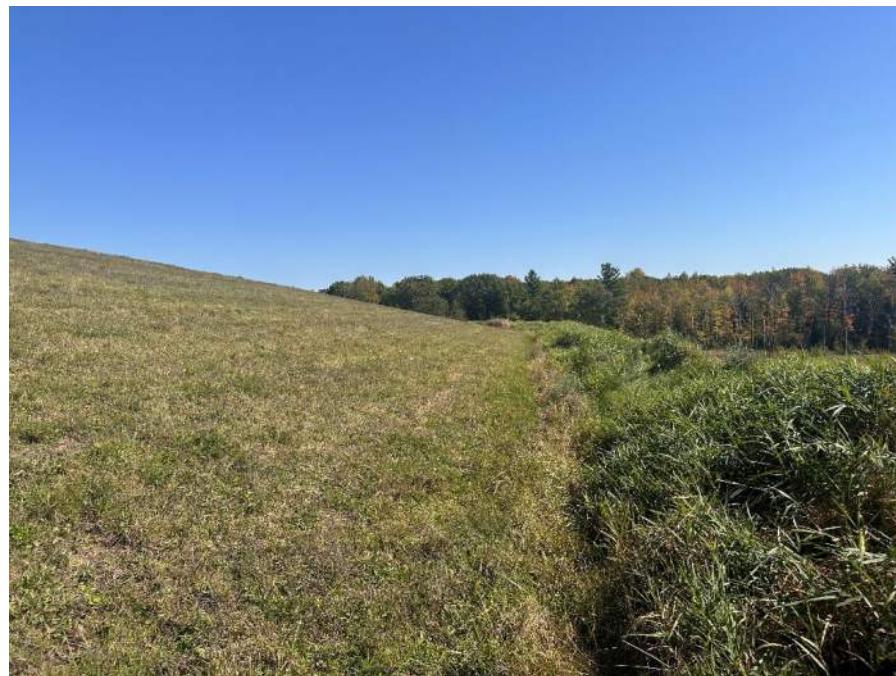
Photo No. 4 – Cell 2 south slope and stormwater diversion berm.

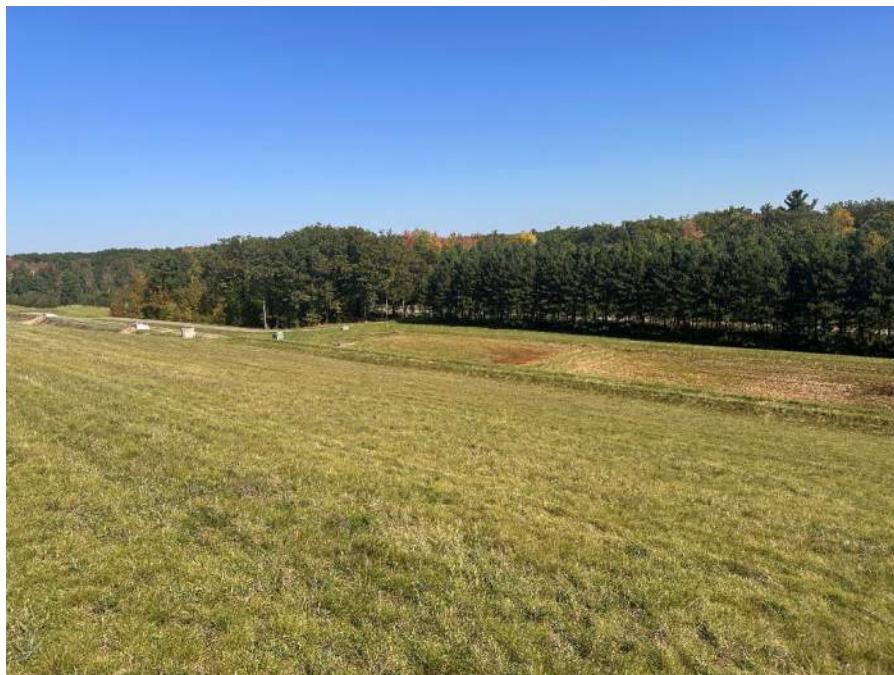
Photo No. 5 – Stormwater Basin 2 east of Cell 2.

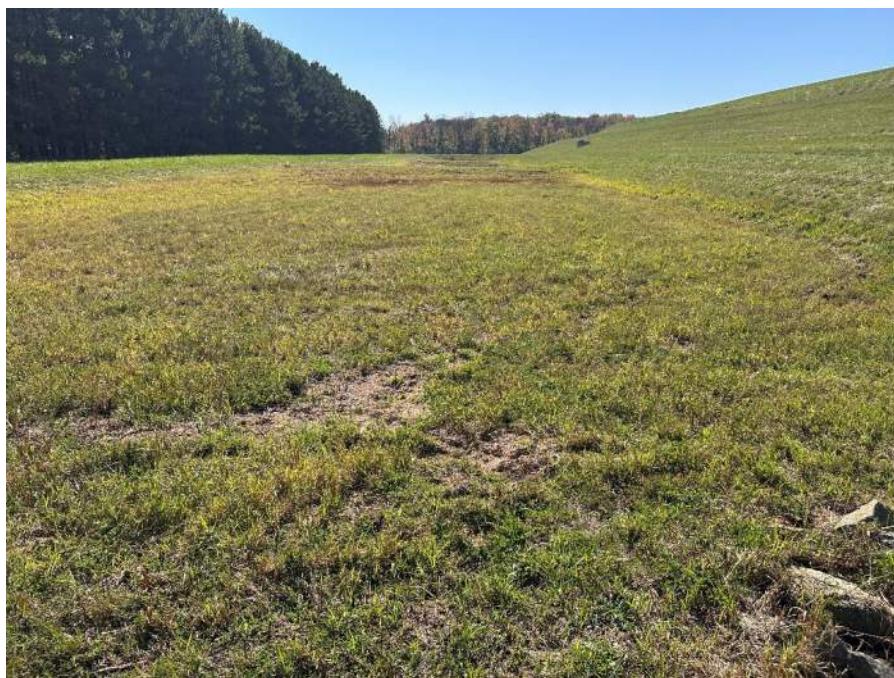
Photo No. 6 – Stormwater Basin 2 and Cell 2 final cover.

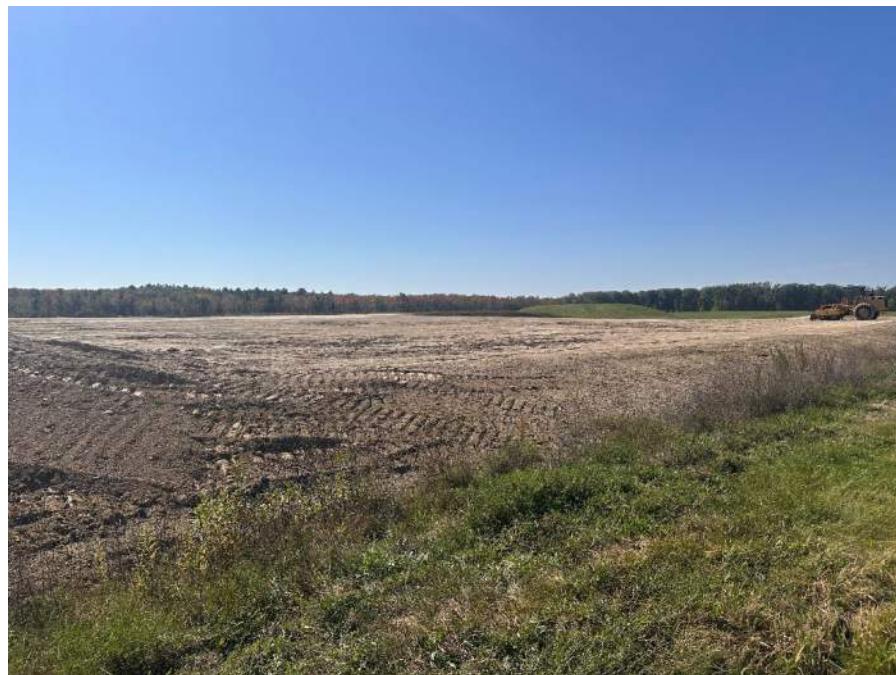
Photo No. 7 – Active filling area in Cell 1, looking south.

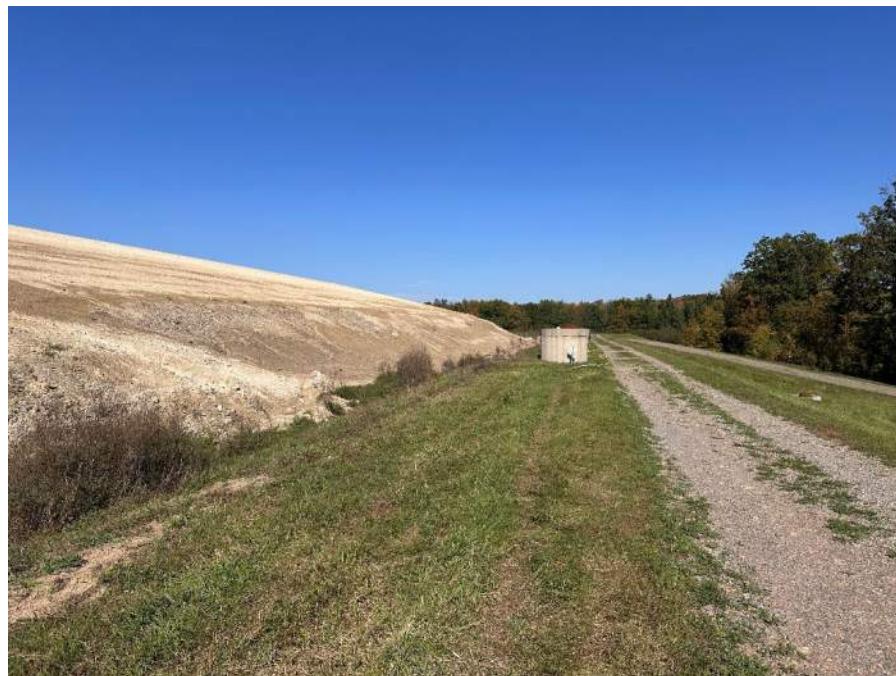
Photo No. 8 – Looking north on the Cell 1 active filling area and the east slope prepared for final cover.

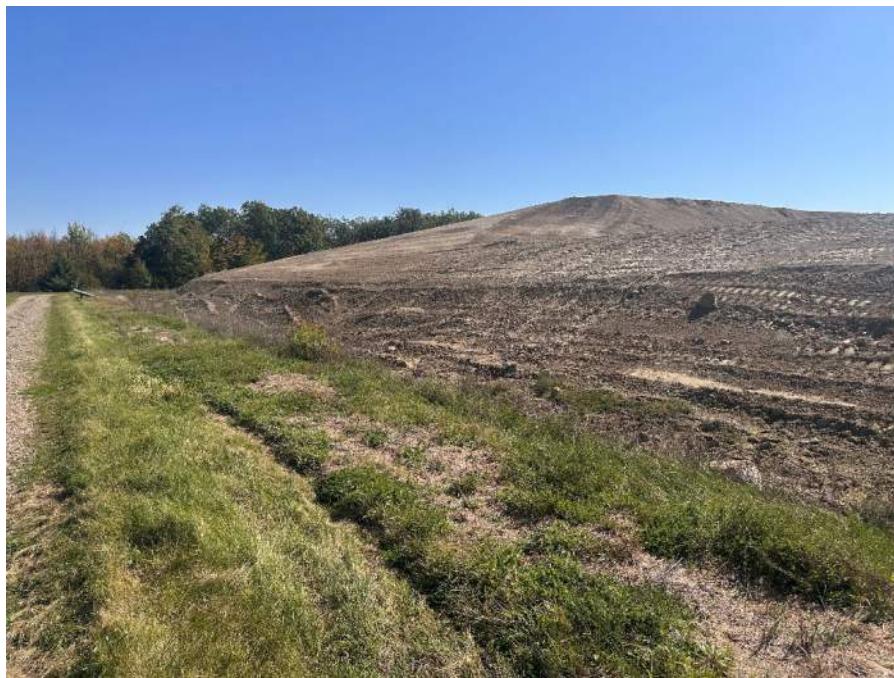
Photo No. 9 – Looking east at the Cell 1 north perimeter slope and leachate collection ditch.

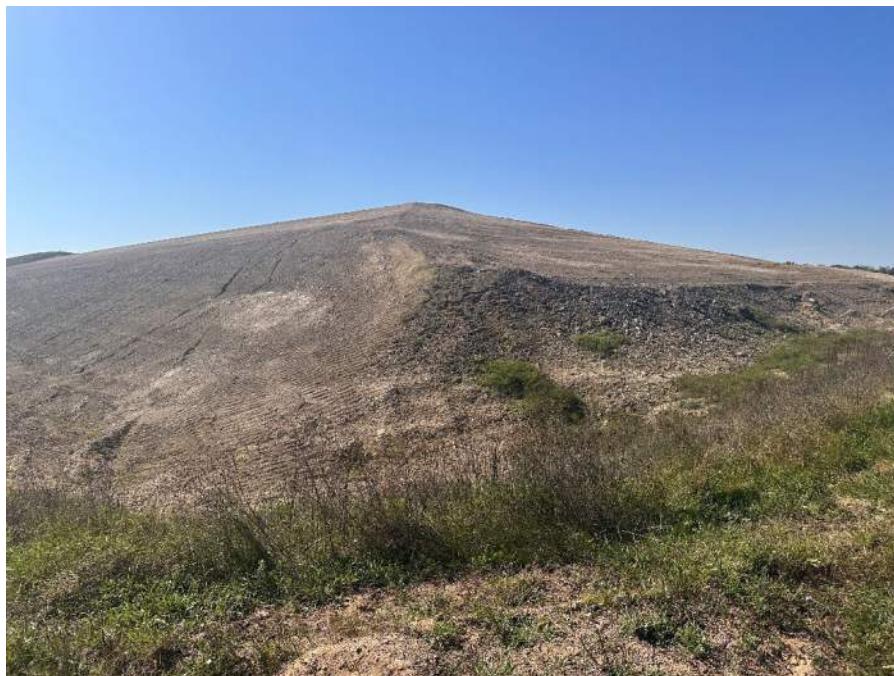
Photo No. 10 – Cell 1 north and east perimeter slopes, looking southwest.

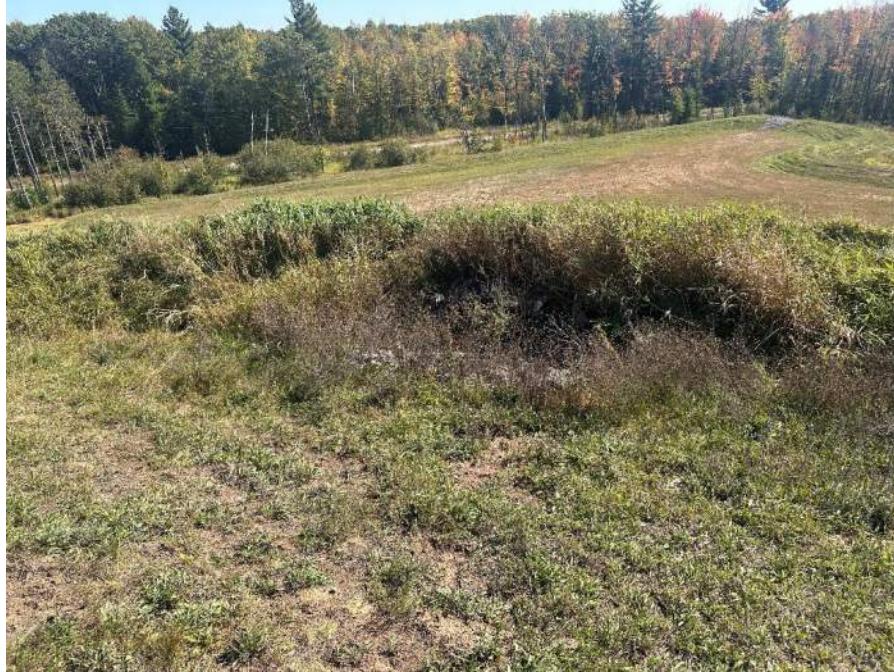
Photo No. 11 – Cell 2 diversion berms and stormwater drain pipe inlet.

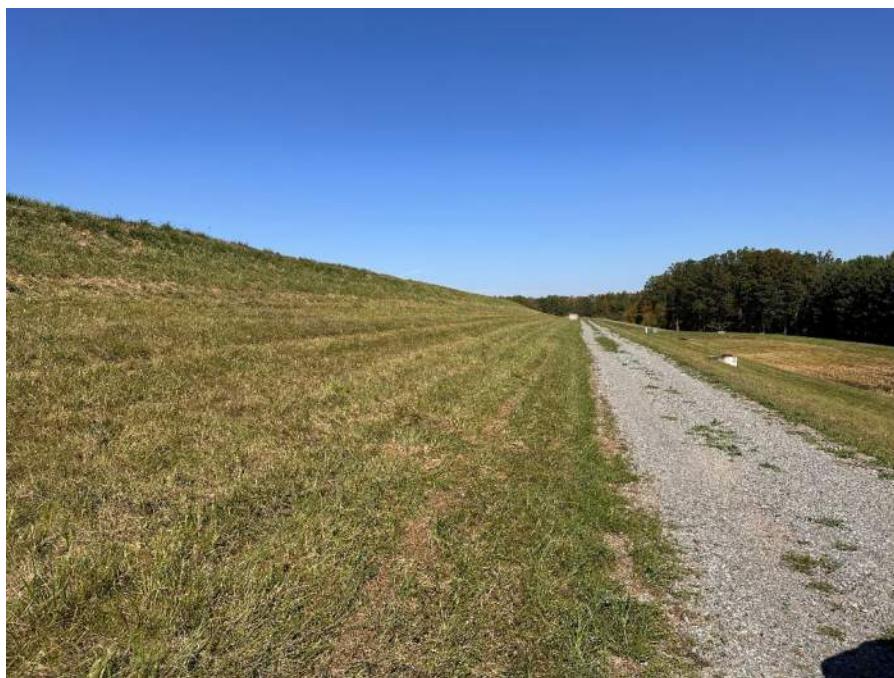
Photo No. 12 – Looking north at the Cell 2 east perimeter slope and diversion berm.

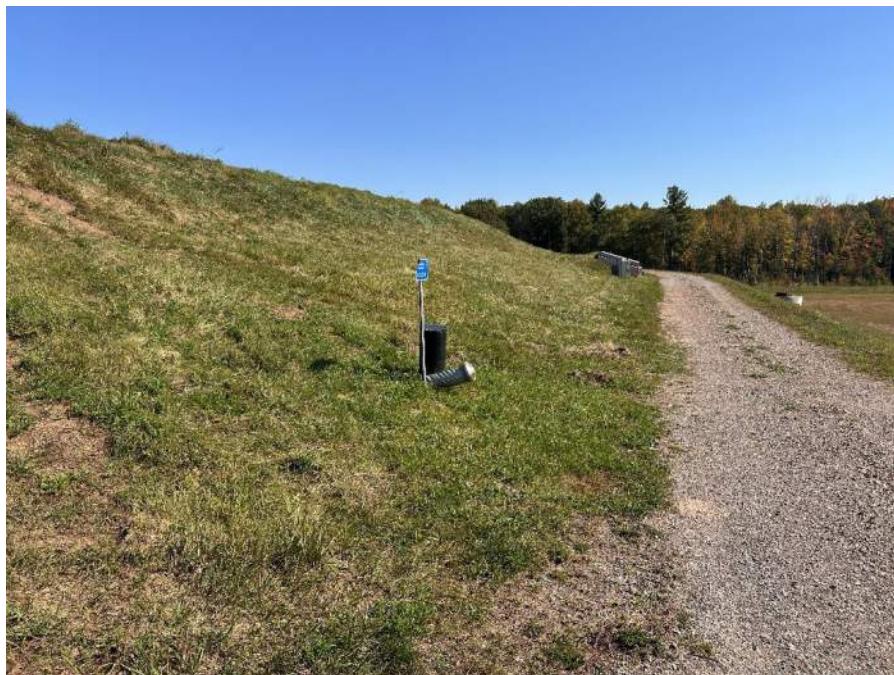
Photo No. 13 – Cell 2 south diversion berm and headwell pipe.

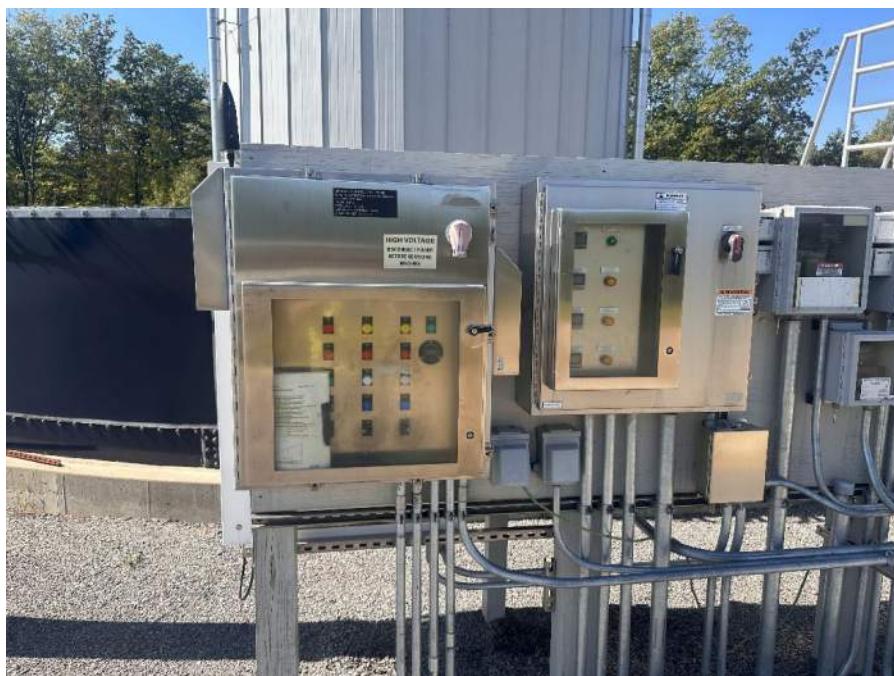
Photo No. 14 – Leachate loadout pad and control panels.

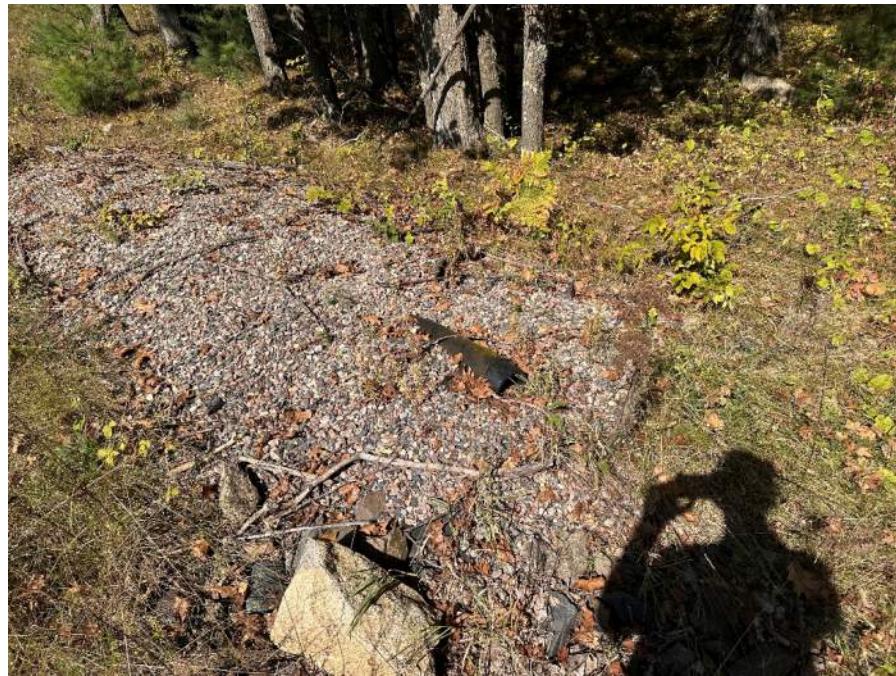
Photo No. 15 – Cell 1 gradient control outlet pipe.

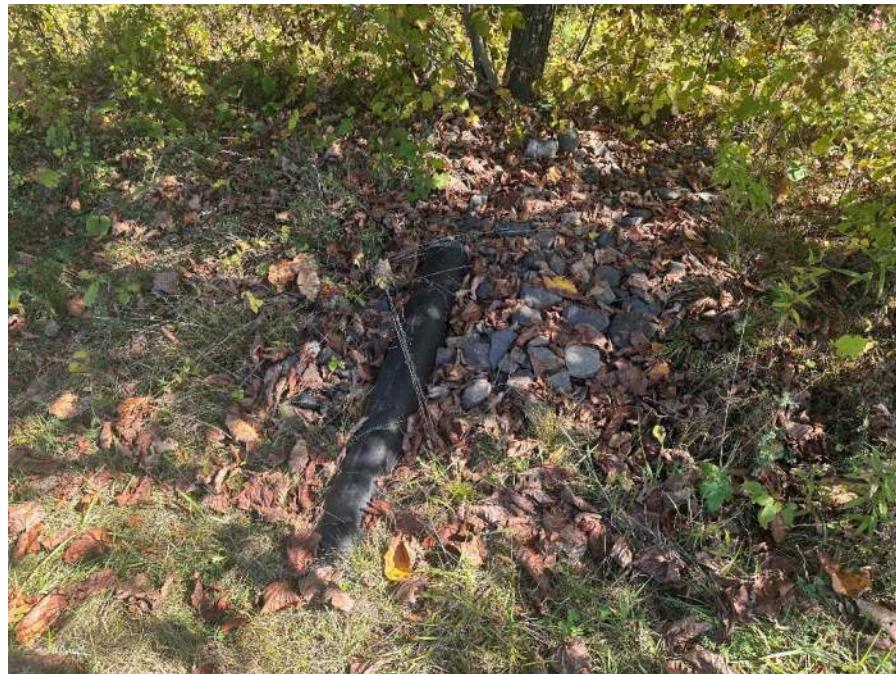
Photo No. 16 – Cell 1 gradient control outlet pipe.
